**KORTEL  
DESIGN**

## ***SAFETY NOTE***

***Non conformity of T-Bone link***

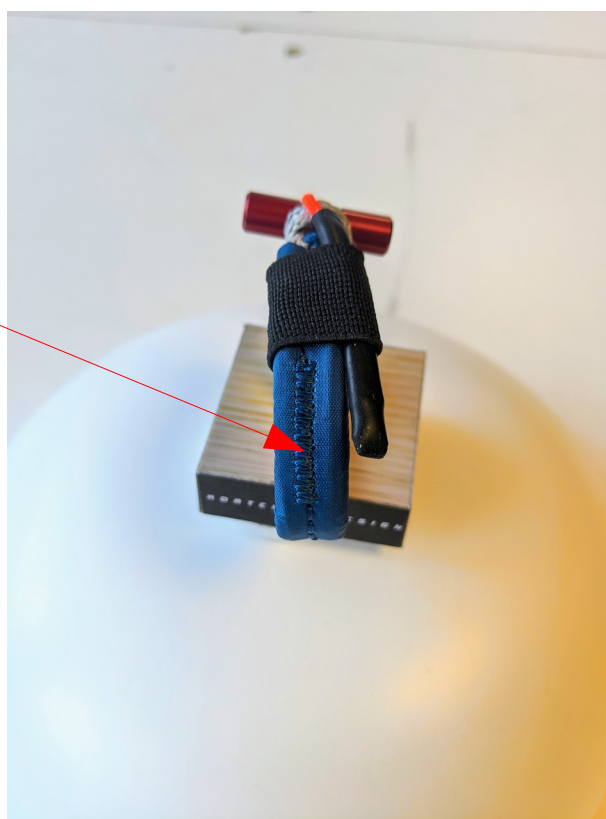
**Non-compliant**

In randomized tests on the strength of T-Bones links, we have just found a break at a value lower than the assumed 24KN.

After analysis, this is a production error in the manufacturing process of the T-Bones link, which is difficult to detect during routine checks.

The T-Bone links in question have a break of between 16 and 18KN.

For simple identification, all T-Bone links with a blue safety bartack seam, the same colour as the protective fabric, are to be considered non-compliant.

However, due to their non-compliance with the 24KN announced, we are recalling and exchanging all T-Bone links delivered as a stand-alone product or with the Kruyer III since October 2019.

The next T-Bone links will be made with a different color bartack to identify them.
